TEST LABORATORY REPORT

REPORT NUMBER: 5693

3x "Large O-Rings"

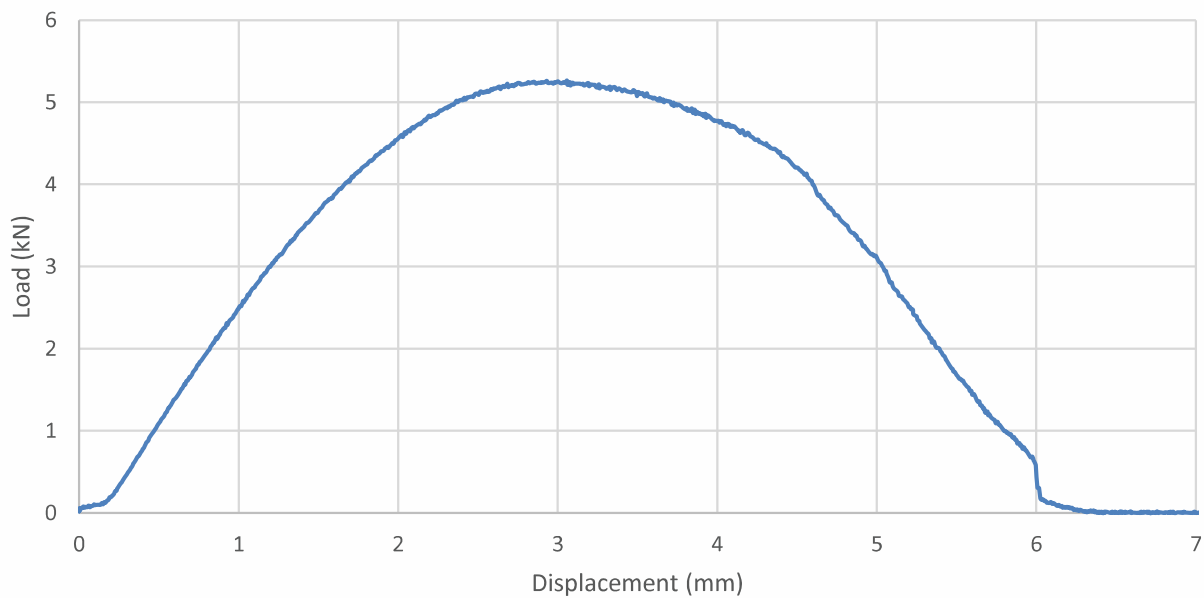
Sample 820 - Large O-Ring #1

Sample ID	Description	Maximum Load	Failure location
820	Large O-Ring #1	5.27 kN	Aluminium Housing
821	Large O-Ring #2	4.99 kN	Aluminium Housing
822	Large O-Ring #3	5.01 kN	Aluminium Housing
823	Large Lead #1	1.47 kN	Plastic Buckle
824	Large Lead #2	1.48 kN	Plastic Buckle
825	Large Lead #3	1.57 kN	Plastic Buckle

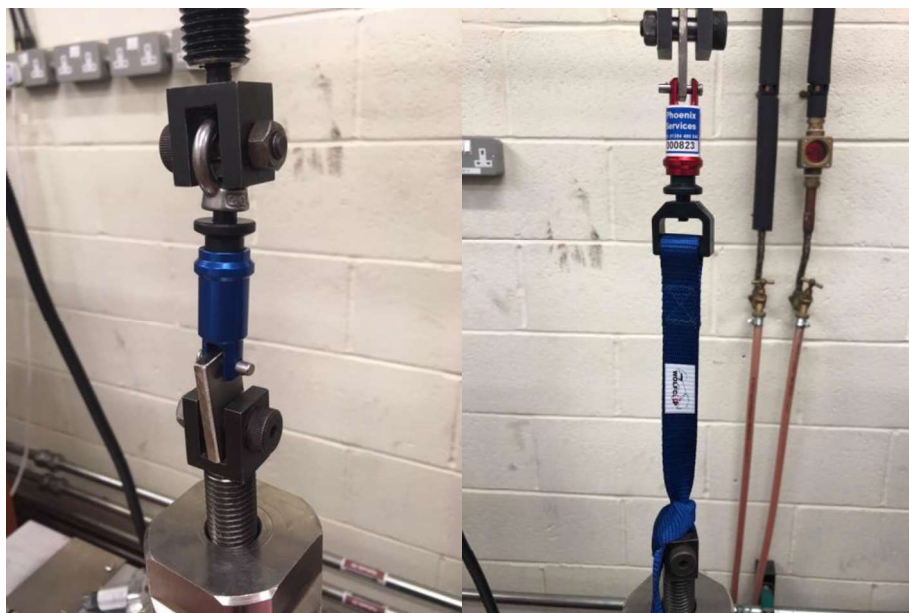
Photo Ref. 5693 Large O-Ring Test Set-Up Photo Ref. 5693 Large Lead Test Set-Up

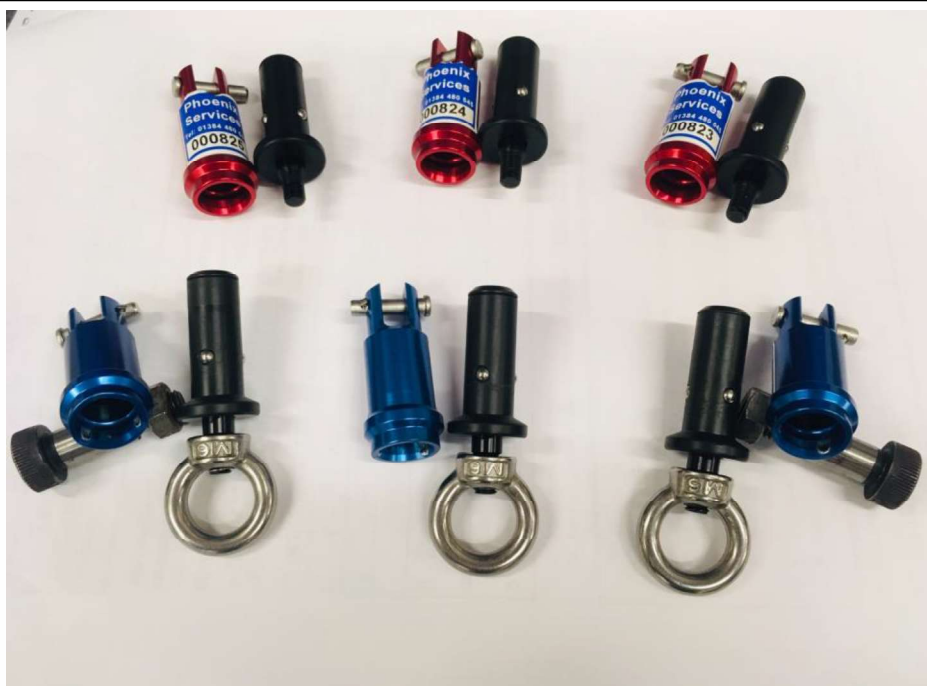
Photo Ref. 5693 Samples Post-Test
